Tropical Storm Isaias

Consolidated Edison, Inc.

Storm Related Outages

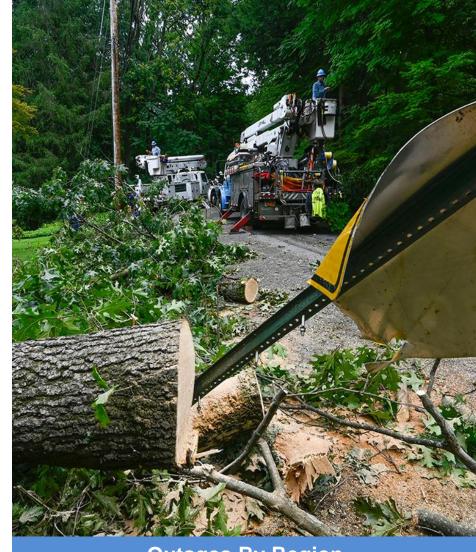
Outages By Region

Bronx: 33,072; Brooklyn: 28,439 Manhattan: 20; Queens: 76,319

Staten Island: 66,221; Westchester: 127,830

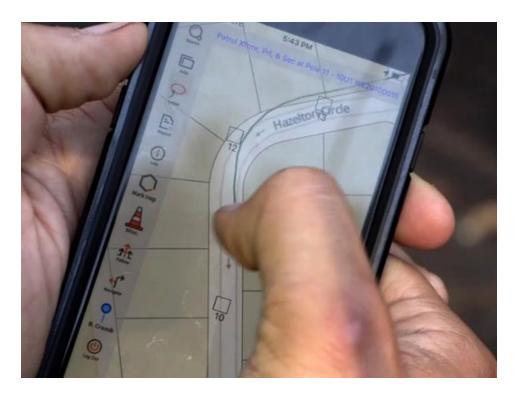
Damage Assessment Mobile App

- Transfers information between Assessors and Engineers
- Available on multiple platforms for employees and contractors
- Enhancements since Riley/Quinn
 - Increased variety of training and inclusion in monthly drills
 - Expanded feeder patrol resources
 - Microsoft Teams and remote dispatching
- Over 9,000 tickets field assessed during Isaias
